## AVIATION INVESTIGATION REPORT

A00H0003

**LOSS OF SEPARATION / SAFETY NOT ASSURED**

**27 MAY 2000**

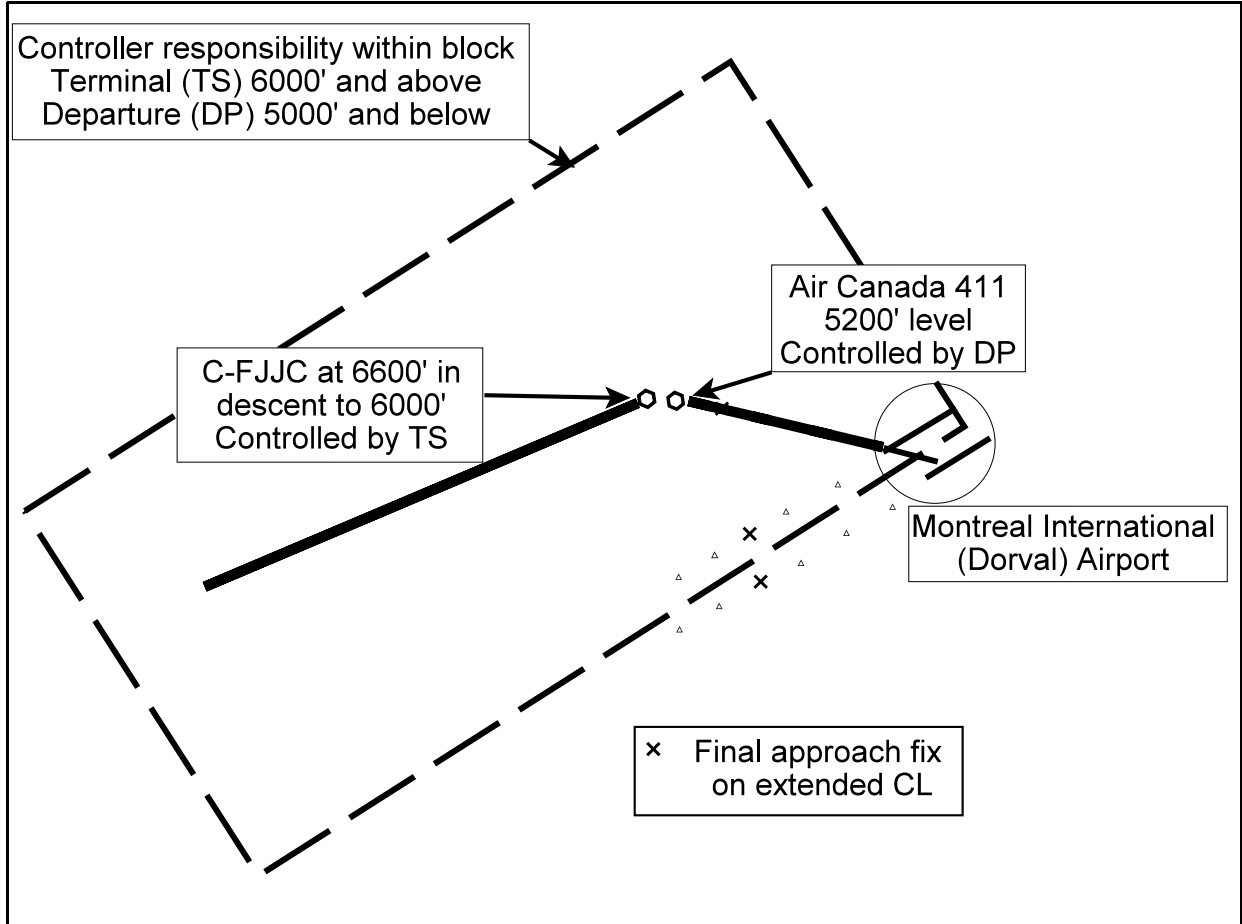
## Appendix A – Airspace Diagram

The airspace in the vicinity of the Montreal airports is divided both horizontally and vertically in order to assign control responsibilities to sector controllers. The airspace sector off the departure end of runway 28 is divided vertically, as indicated in Appendix A. According to *Montreal Terminal Operational Procedures*, Annex D, the airspace up to and including 5000 feet is

in the jurisdiction of the departure controller; the airspace at 6000 feet and above, as in this occurrence, was in the jurisdiction of the terminal south controller.

Aircraft positions about 10 seconds after the traffic advisory from TCAS
